U.S. DOT Region 3 University Transportation Center

## **Durability Assessment of Externally Bonded Fiber-Reinforced Polymer (FRP) Composite Repairs in Bridges**

**November 30, 2022**

**Ajay Baniya, Sandra Milev, Rachel Henry, Jovan Tatar  
University of Delaware**

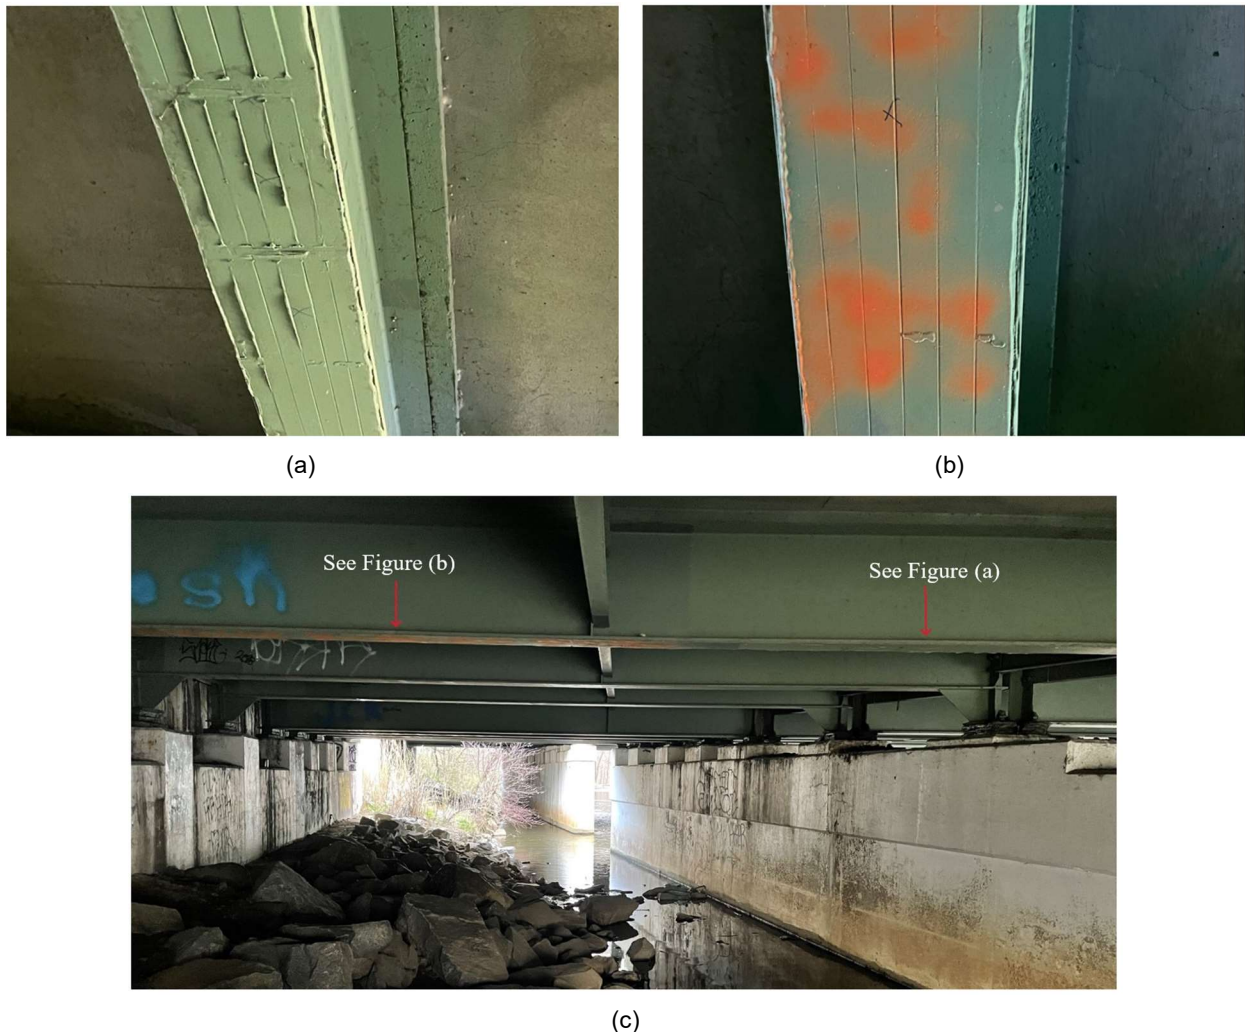
**Figure 75. Condition of CFRP composite girder repaired in 2000.**

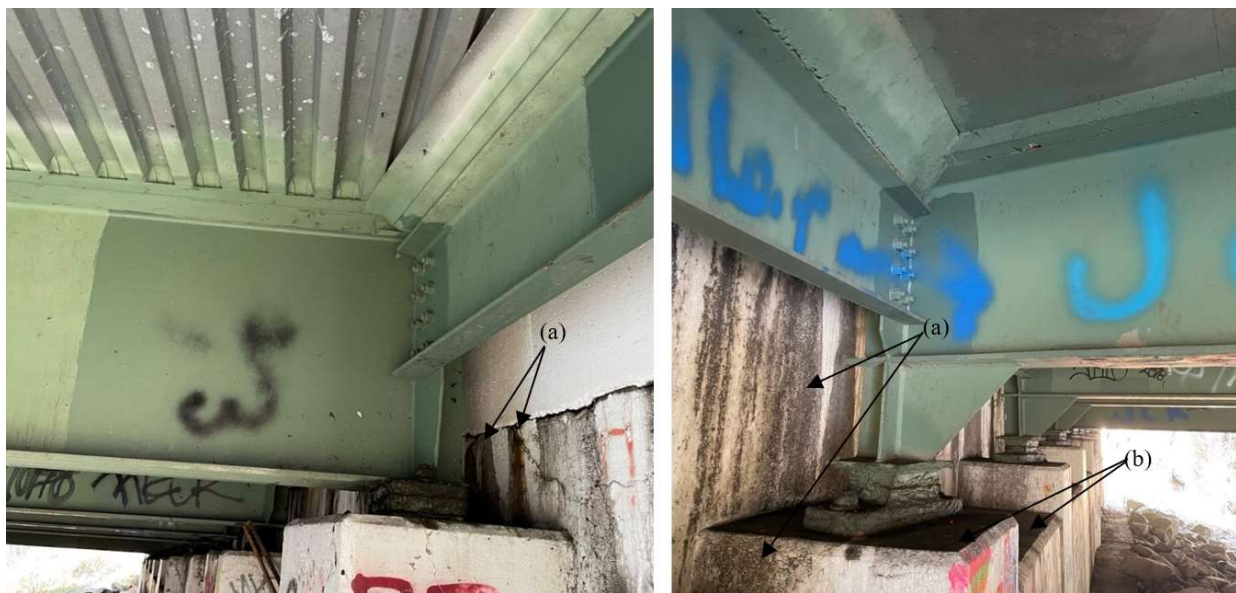
Notes: (a) Stains visible on the concrete retaining wall and abutment; (b) fine sediment aggregates visible on top of concrete abutment.

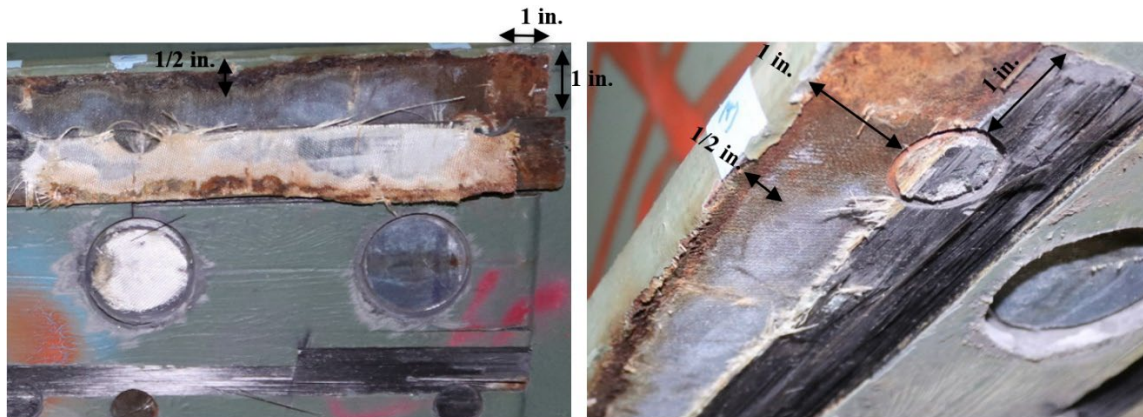
**Figure 88. Presence of rust on the northern end of the girder, located 4–10 ft. away from the centerline of abutment 2 (shown in Figure 55).**

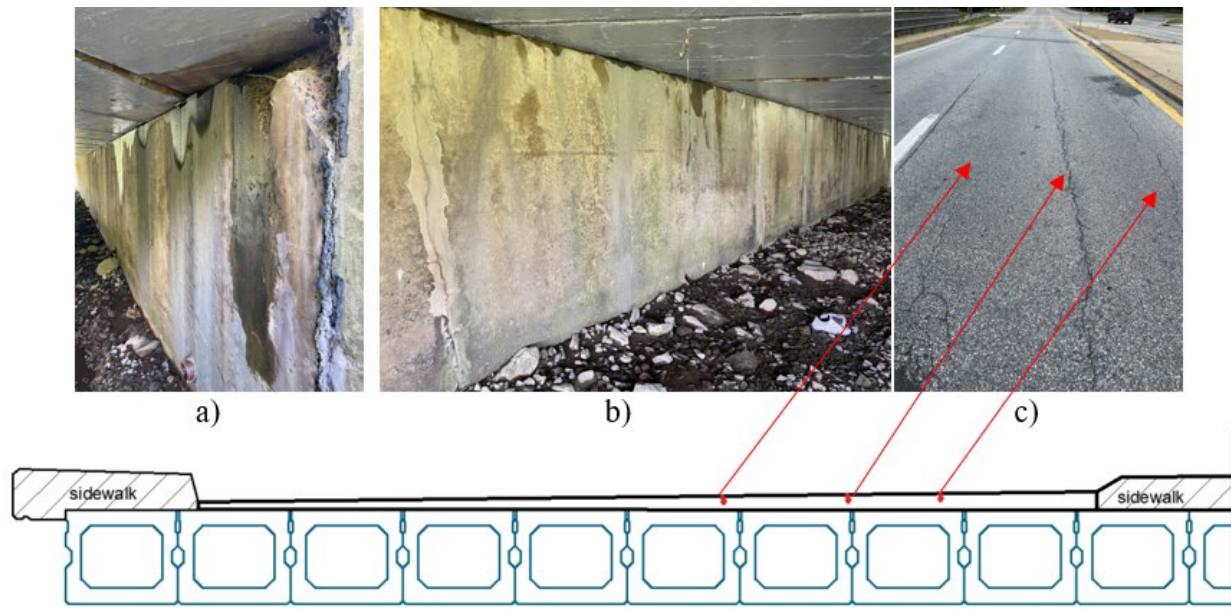
**Figure 95. (a) Spalling of the south abutment wall, (b) vertical cracks in the abutment wall, and (c) reflective cracking of the asphalt pavement.**

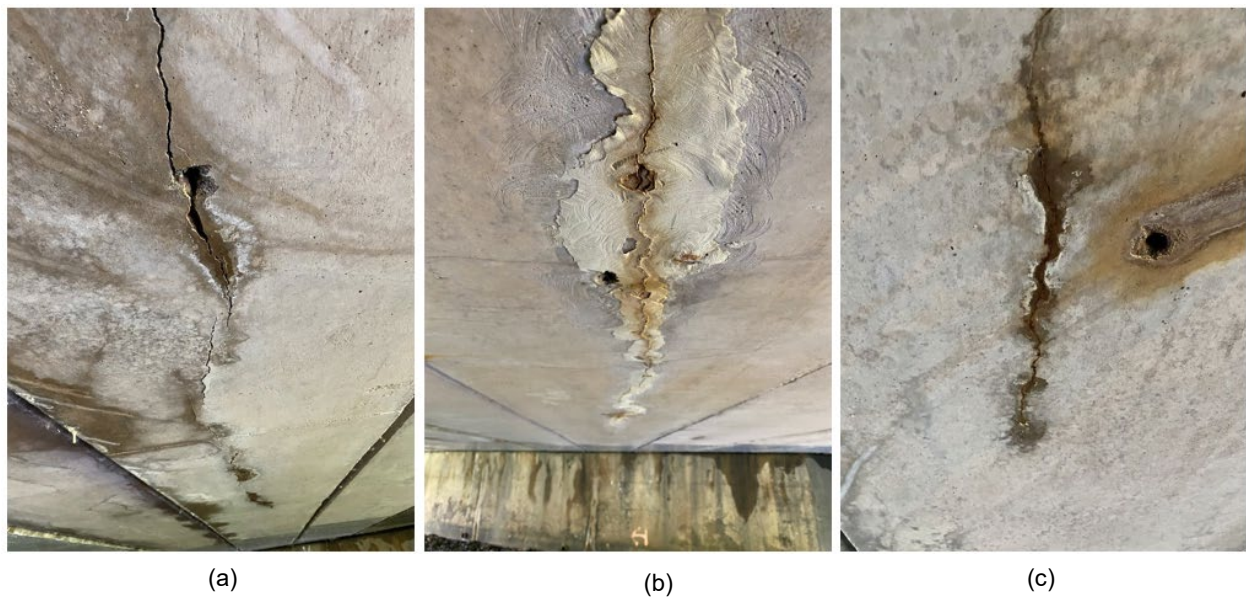
**Figure 96. Longitudinal cracks in G7, G15, and G17.**

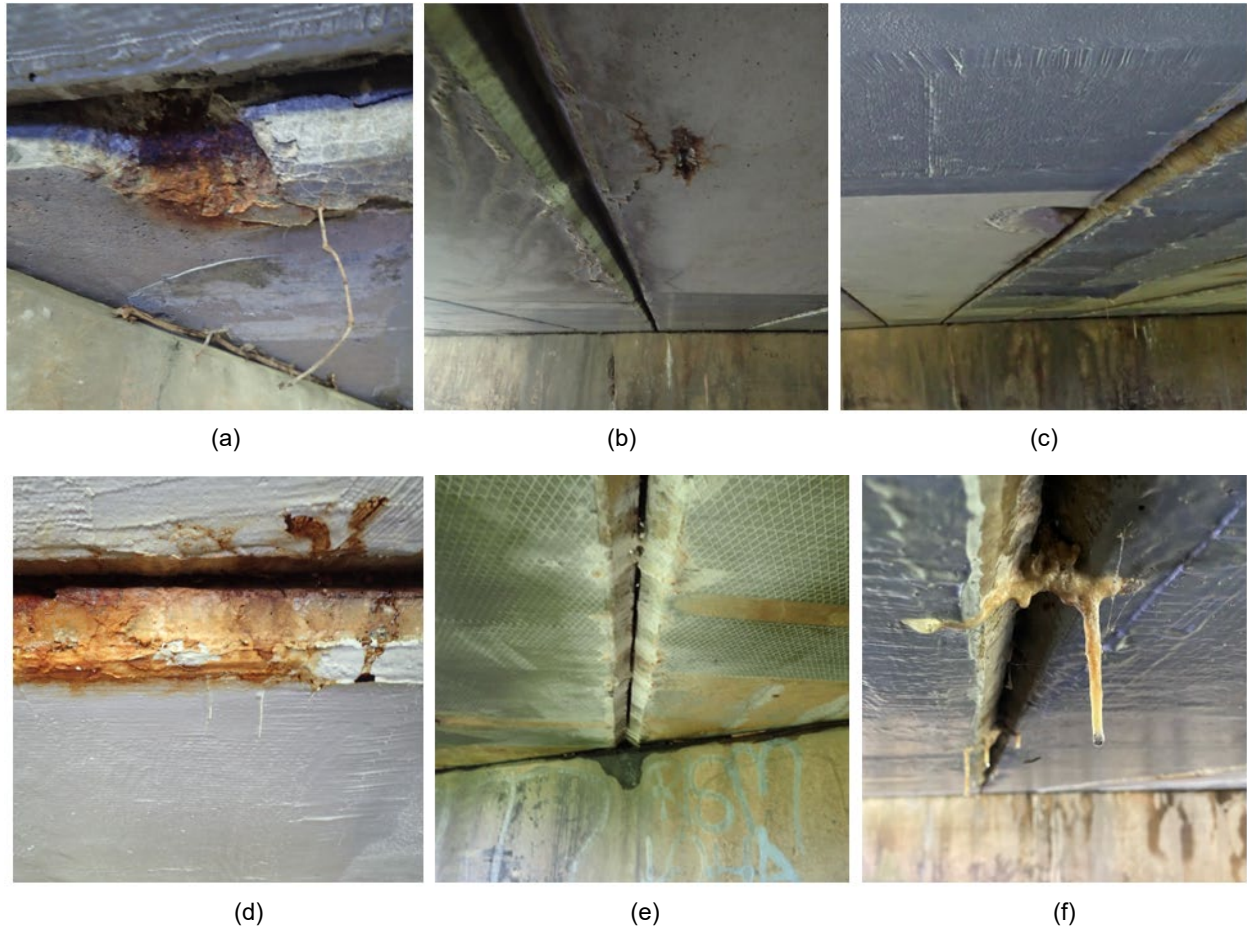
**Figure 97. Examples of damaged girders and condition of joints: (a,b,c) concrete spalling, (d) motor oil in the joint, and (e,f) efflorescence.**

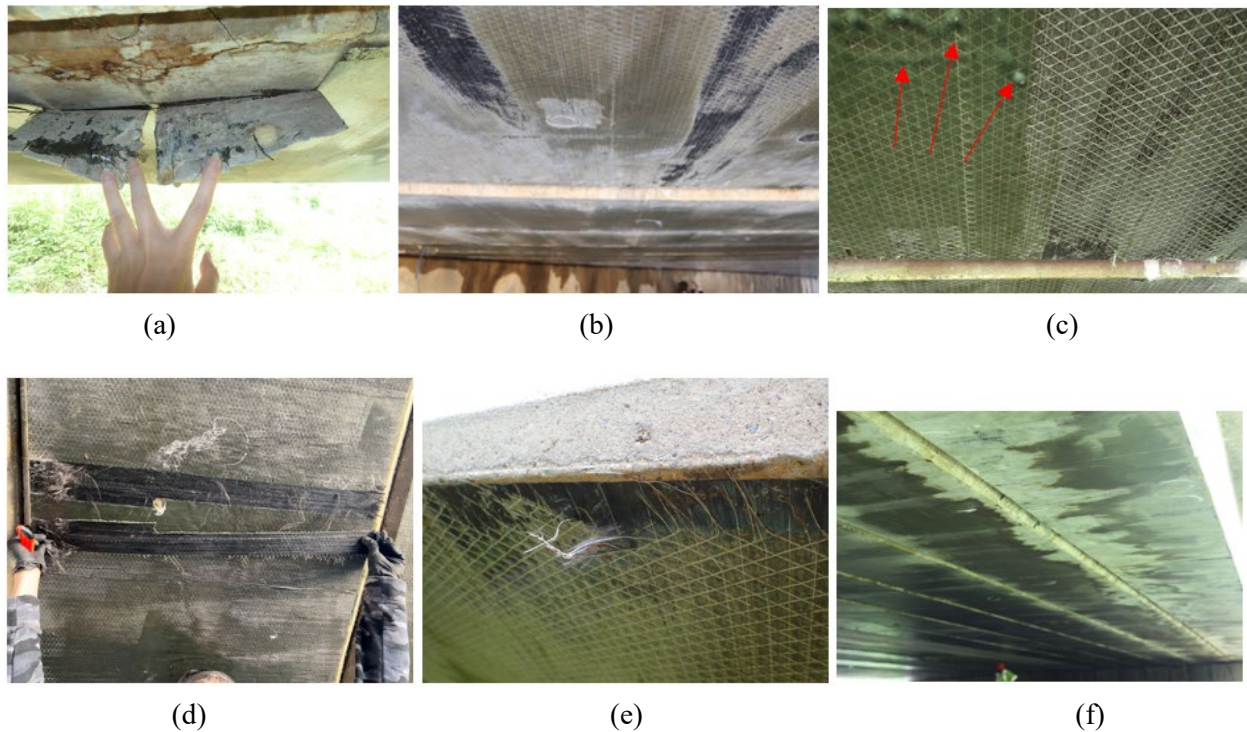
**Figure 98. Examples of damage of unidirectional CFRP: (a) end peeling, (b) insufficient saturation, (c) blistering, (d) delamination, (e) frayed fiber, and (f) water stains.**

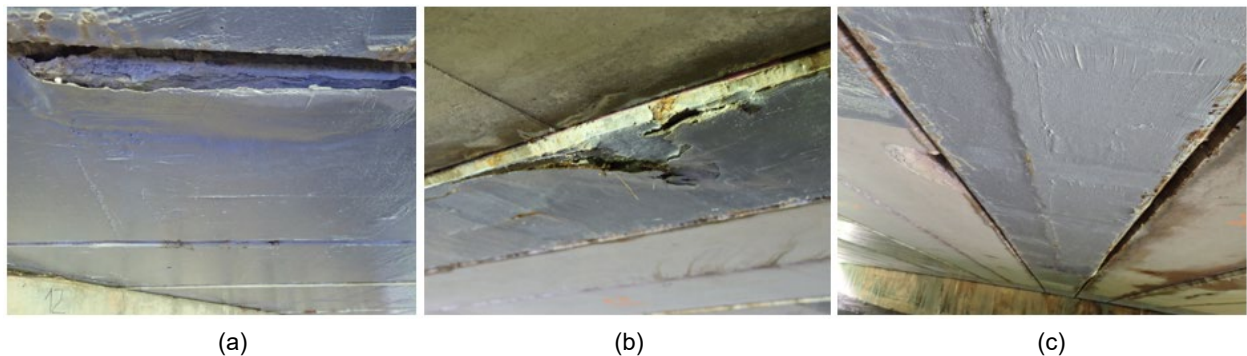
**Figure 99. Examples of damage of bidirectional CFRP: (a,b) spalling/CFRP tearing, and (c) bulging below the CFRP indicates the presence of a longitudinal crack.**

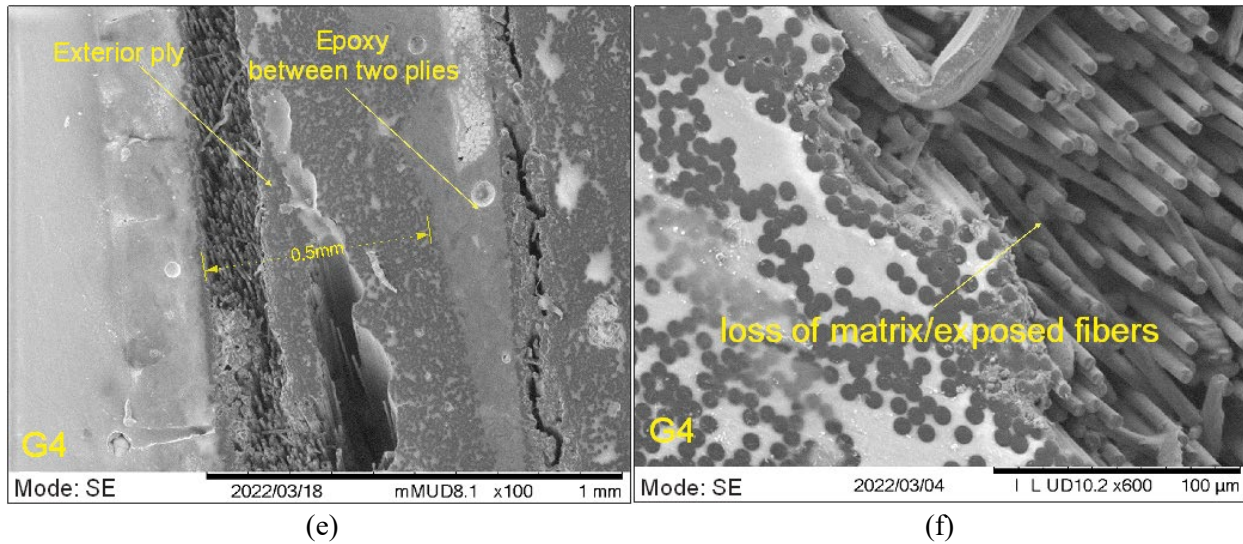
**Figure 104. SEM images of CFRP: (a) cracking at the fiber/matrix interface in G1, (b) cracking in the region of closely spaced fibers in G6, (c) bidirectional CFRP, (d,e) cracking and loss of matrix two-ply CFRP on G4, and (f) high magnification image showing exposed fibers in G4.**

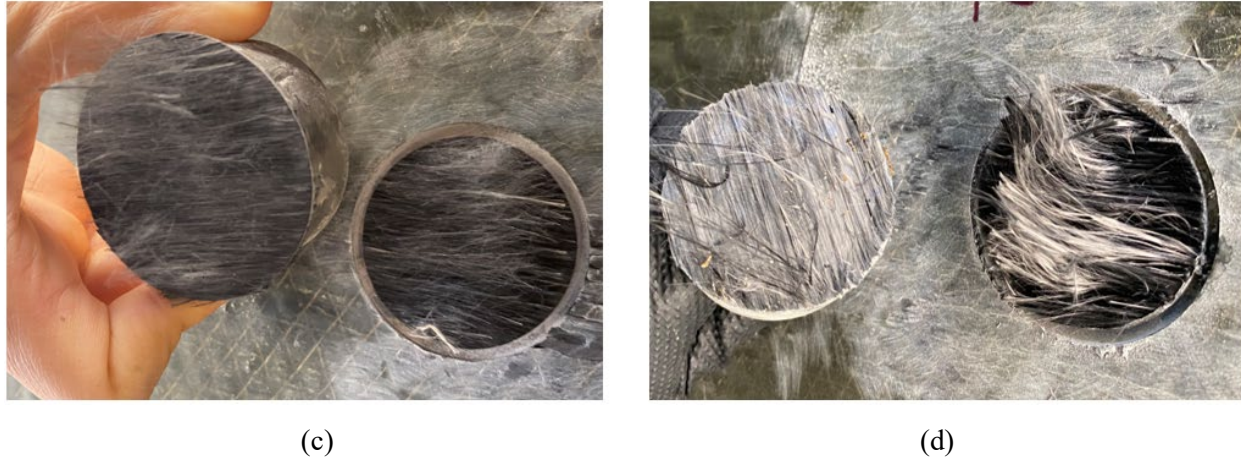
**Figure 107. Two failure modes observed: (a) mode B on G1-U1, (b) mode E on G23-B1, (c) mode B on G4-UD1, and (d) mode B on G4-UD2.**
