U.S. DOT Region 3 University Transportation Center

## **Durability Assessment of Externally Bonded Fiber-Reinforced Polymer (FRP) Composite Repairs in Bridges**

**November 30, 2022**

**Ajay Baniya, Sandra Milev, Rachel Henry, Jovan Tatar  
University of Delaware**

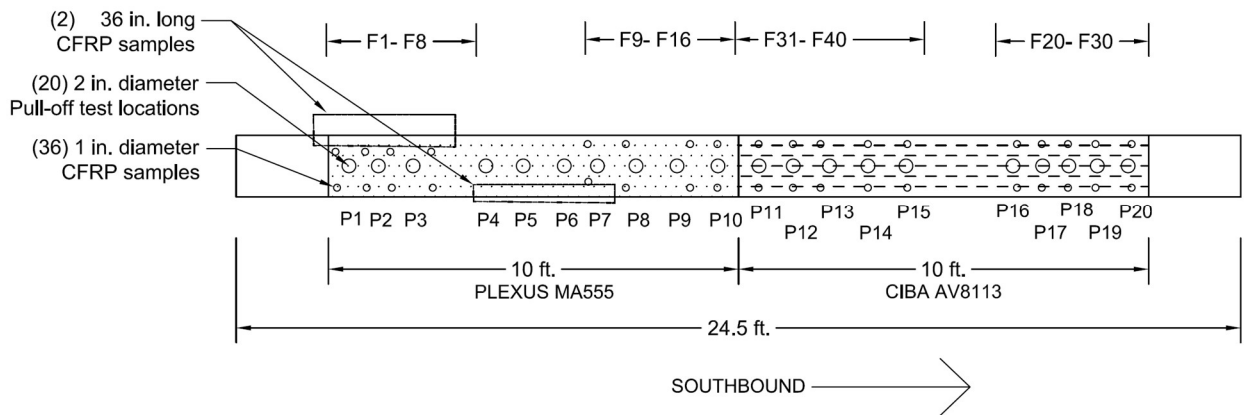
- Notes: 1. Tentative location of pull-off tests, P1 through P20 (Figure 64). A minimum clear spacing of 6 in. between each test location and a minimum clear distance of 3 in. from the edge is maintained at all test locations.
- 2. Tentative location of 1-in.-diameter CFRP samples, F1 through F40 (Figure 63). Minimum clear spacing of 3 in. between each location is maintained at all test locations.
- 3. Figure not drawn to scale.

**Figure 62. Bottom view of the girder G5 showing the tentative location of sample collected and pull-off tests.**

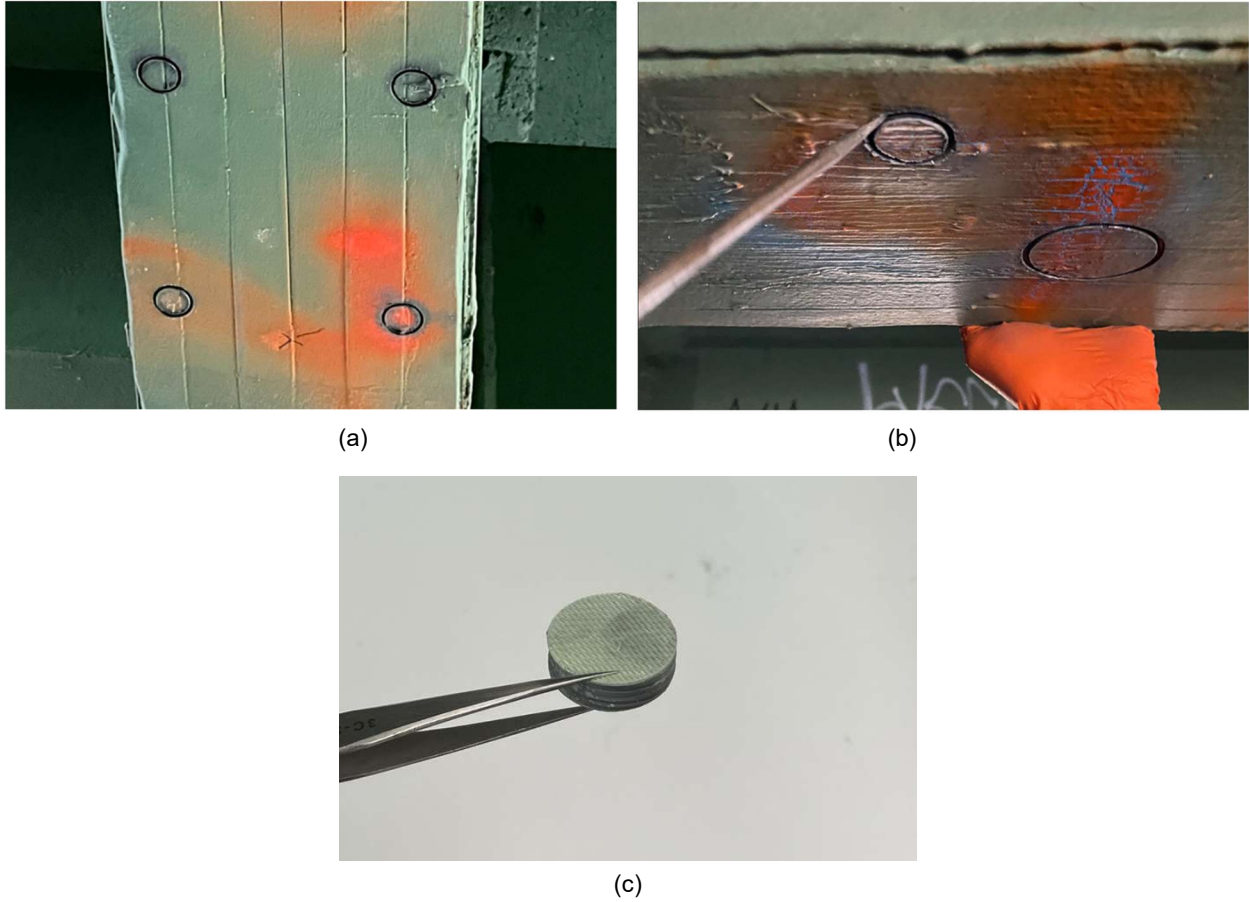
**Figure 65. CFRP sample collection at Br 1-704: (a) CFRP composite drilled using a 1-1/8-in. diamond-coated core saw, (b) sample collection under progress using flat-head screwdriver, and (c) 1-in.-diameter CFRP sample.**

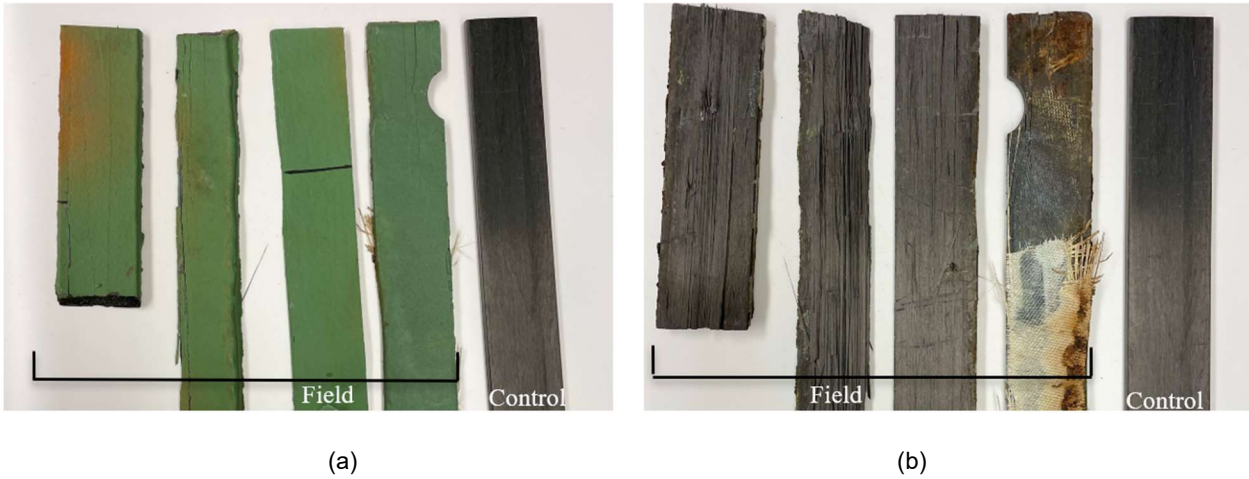
**Figure 66. Field samples from Br 1-704 and control sample : (a) paint side of composite samples shown, and (b) other side of the samples.**

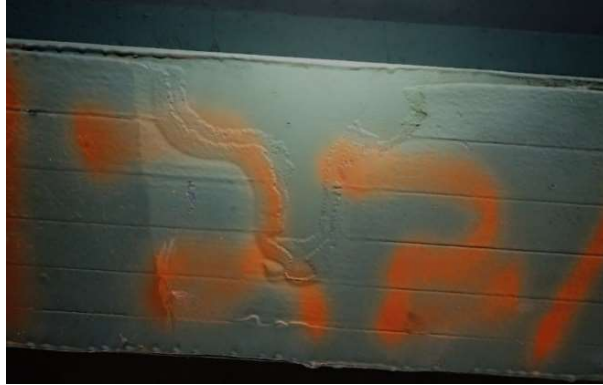
A preliminary visual investigation of the CFRP composite repairs did not indicate the presence of obvious degradation, as shown in Figure 75. However, it was observed that approximately 6×6 in.<sup>2</sup> of CFRP composite was grit blasted, as shown in Figure 76. According to DelDOT, it was grit blasted during the surface preparation work prior to the application of the paint on the soffit of the girder. The accessible part of the girder (Figure 75b,c) was found painted with graffiti paint. The abutments and concrete deck were inspected periodically throughout the year 2021, and it was observed that the moisture infiltrated the abutment during rainy days, as shown in Figure 77. No signs of ingress of direct rainwater runoff from the roadway were observed on the CFRP composite during the inspection.

**Figure 76. Damage to CFRP laminate from grit blasting.**

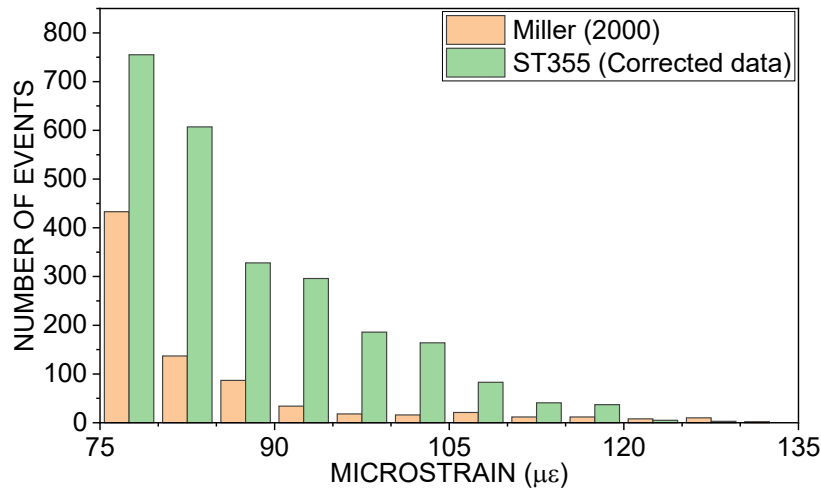
Given that existing state truck size and weight limit laws were found to be consistent nationwide since 1991 (FHWA, 2015), such a drastic increment in peak strain count (Figure 80) possibly indicates the reduction in global stiffness of the girder. The exact loss in global flexural stiffness of the girder could not be quantified because the diagnostic load tests (i.e., with controlled load magnitude and position) were not performed. The degradation of CFRP composite or the bond strength due to environmental conditioning could have potentially affected the stiffness, but there could have been several other factors affecting the loss in stiffness of the girder. For instance, even though the girders were designed non-compositely, the contribution in stiffness due to the interaction of the steel girder-concrete deck was not evaluated at any stage of the service life of the bridge. In case there was composite action due to the concrete deck, the presence of cracks in concrete, loss of bond, etc. could result in stiffness degradation. Similarly, no studies were conducted to assess the cyclic strength degradation of girder due to dynamic loading, which could lead to a significant increase in peak displacement demands (Veletsos and Newmark, 1960). Overall, it was not possible to quantify the effect of environmental degradation in the reduction of global stiffness of the girder; thus, additional experimental tests need to be performed in the field and laboratory.

Figure 80. Number of peak live load strain events above threshold at ST355 vs. Miller (2000).

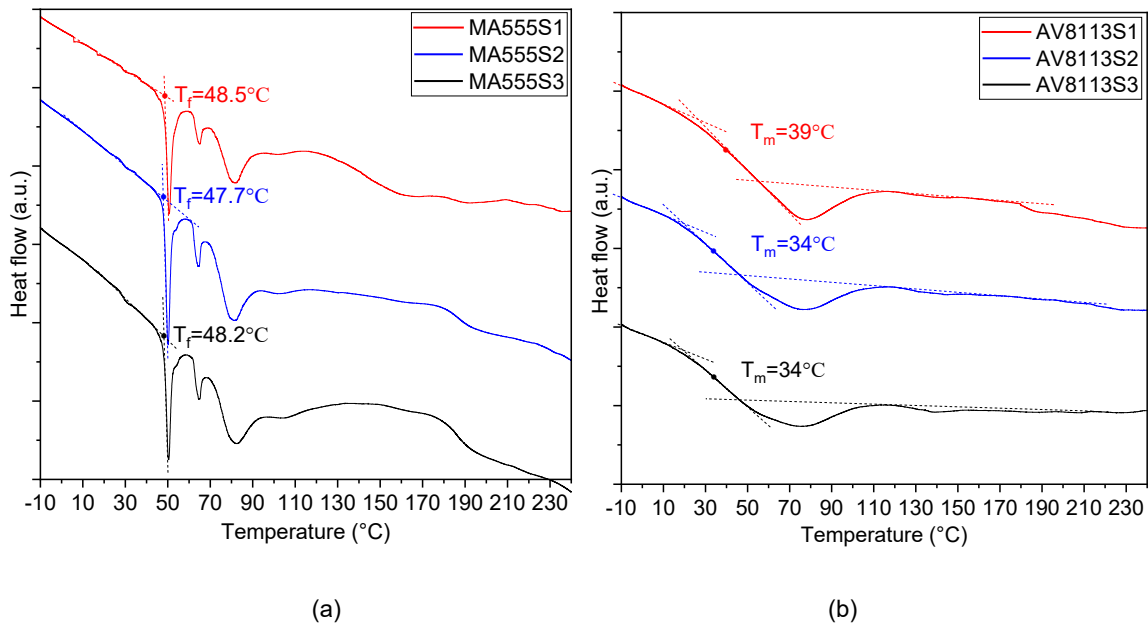
As shown in Figure 85, the heat flow was plotted as a function of the temperature to determine the  $T_g$  of the structural adhesive samples collected from girder G5. The midpoint temperature ( $T_m$ ) was selected as the  $T_g$  for AV8113 structural adhesives, since it is constructed closer to the middle of the temperature range over which the glass transition occurs. The first baseline was constructed to the heat flow curve before the transition temperature, and the linear portion during the phase transition was extrapolated until it intersected the first baseline to determine the  $T_f$  per ASTM E1356-08 (2014). The second baseline was then established to the heat flow curve after the transition temperature. The linear portion during the phase transition was again extrapolated to meet the second baseline; the point of intersection is referred to as extrapolated end temperature ( $T_e$ ). An average midpoint temperature ( $T_m$ ) for AV8113 was  $35.7 \pm 2.4$  °C, which was found significantly lower than the glass transition temperature (i.e., 90 °C) reported by West (2001).

The extrapolated onset temperature ( $T_f$ ) was selected as the  $T_g$  for MA555 structural adhesives because of the inability to establish the second baseline for determination of midpoint temperature. The first baseline was constructed to the heat flow curve before the transition temperature, and the linear portion during the phase transition was extrapolated until it intersected the first baseline to determine the  $T_f$  per ASTM E1356-08. Several endothermic peaks were observed immediately after the phase transition, as shown in Figure 85a. An average extrapolated onset temperature ( $T_f$ ) for MA555 was  $48.1 \pm 0.3$  °C, which was found to be lower than the glass transition temperature (i.e., 103 °C) reported by West (2001).

The  $T_g$  of both structural adhesives were found to be well below the minimum temperature of 66 °C as recommended by AASHTO (2012) and their respective control samples (Figure 86). Some reduction in  $T_g$ , similar to vinyl ester, may be due to moisture ingress. The field samples were cured at the field conditions, but the curing information of the control samples was not known. The higher  $T_g$  of the control samples could be due to the controlled curing at laboratory conditions. In conclusion, the observed  $T_g$  of both structural adhesives were found below the minimum requirement, which is concerning; the  $T_g$  of the field sample may have been reduced due to moisture ingress; however, the cure phenomenon of the

Figure 85. Glass transition temperature measured on samples from girder G5: (a) MA555 samples and (b) AV8113 samples.

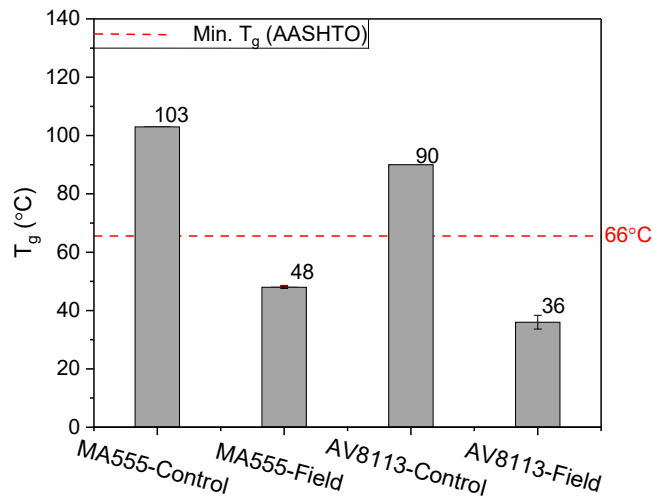
Figure 86. Average glass transition temperature of control and field structural adhesive samples.

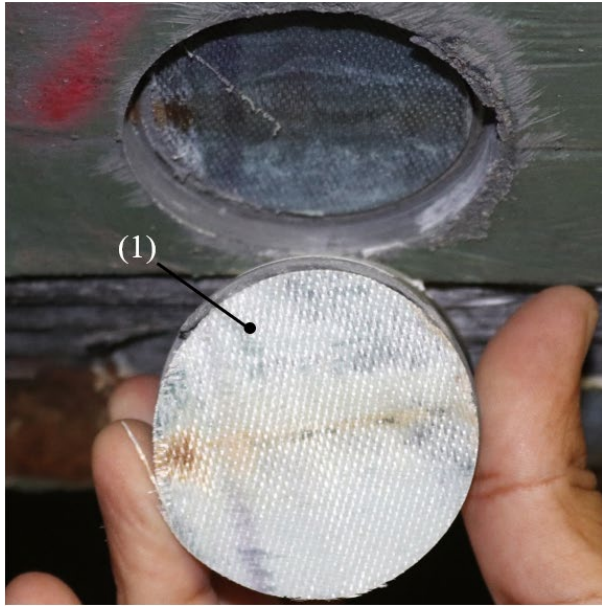
Bond pull-off test results are presented in Table 6, and the photos of observed failure modes are shown in Figure 87. The nomenclature of the sample (e.g., P1) implies the pull-off test at girder G5 and sample number 1. The approximate test locations are shown in Figure 62 and the exact locations are shown in Table 6 with respect to the centerline of the bearing at abutment 2 (Figure 55). A total of 20 tests were performed on the girder, out of which only two samples, P1 and P2, failed in the acceptable mode of failure (Mode C per ASTM D7522, 2021), where the adhesive failure in the adhesive/glass-fabric interface was observed.

Table 6 shows that the bond strength for two samples, P1 and P2, was significantly below the minimum recommended bond strength value for various coating or paint system (Table 5). A careful observation at those test locations post-testing indicated inadequately saturated glass-fiber fabric and the presence of air bubbles trapped at the adhesive/glass-fiber fabric interface as shown in Figure 87a,b. Such failure at the adhesive/glass-fabric interface indicates issues with surface preparation, poor workmanship, or a combination thereof. The pull-off bond strengths at all the remaining 16 test samples, except P14 and P15, were found to be significant, as high as 1.6 to 4.6 times above the minimum bond strength values shown in Table 5.

Test No.	Distance from North Support (ft. in.)	Adhesive	Bond Strength (psi)	Failure Mode	Interpretation of Failure Mode	
P1	2 ft. 9 in.	Plexus MA555	42	Failure Mode C-Adhesive failure at Adhesive/glass-fiber fabric interface	Indicates poor adhesion properties likely resulting from contamination, incomplete cure, environmental degradation, or improper installation.	
P2	3 ft. 6 in.		38			
P3	4 ft. 4 in.		Ciba AV8113	>1,145	No failure mode observed, the maximum capacity of the pull-off tester reached	Pull-tests were not successful because of the limited pulling capacity of the pull-off tester.
P4	6 ft. 1 in.					
P5	7 ft.					
P6	8 ft.					
P7	8 ft. 10 in.					
P8	9 ft. 9 in.					
P9	10 ft. 9 in.					
P10	11 ft. 9 in.					
P11	12 ft. 9 in.					
P12	13 ft. 7 in.					
P13	14 ft. 5 in.					
P14	15 ft. 4 in.	Ciba AV8113	514	Failure Mode A-Bonding adhesive failure at loading fixture	Indicates poor adhesion between the bonding adhesive and the puck, which could be due to poor or inadequate surface preparation or treatment, or improper installation.

Notes: 1. Glass-fiber fabric observed to be inadequately saturated. 2. Air bubbles trapped at the adhesive/glass-fiber fabric interface. 3. Clean surface of puck visible, no hint of "Sikadur-30" epoxy. 4. Sikadur 30 epoxy residue. 5. Cohesive failure of CFRP composite.

**Figure 87. Failure modes observed at different location of G5: (a) mode C at P1, (b) mode C at P2, (c) mode A at P14, and (d) mode A at P15.**

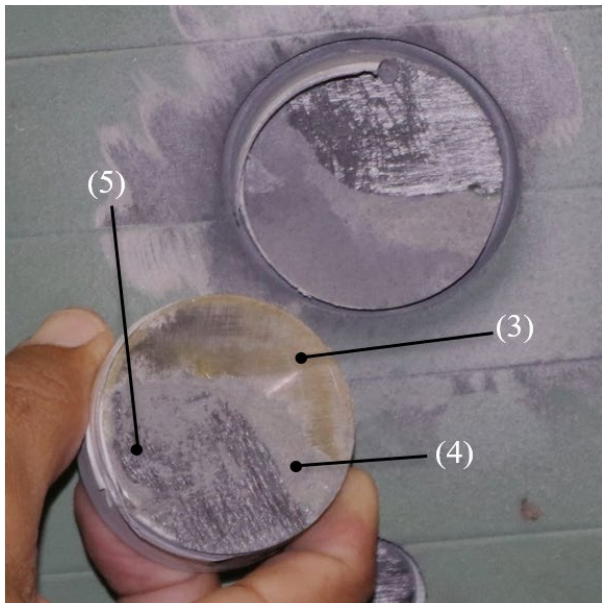
(c)

An additional two samples, P14 and P15, saw bonding adhesive failure at the loading fixture, which is not an acceptable failure mode per ASTM (2021). The remaining samples did not fail as the capacity of the pull-off tester (1145 psi) was reached.

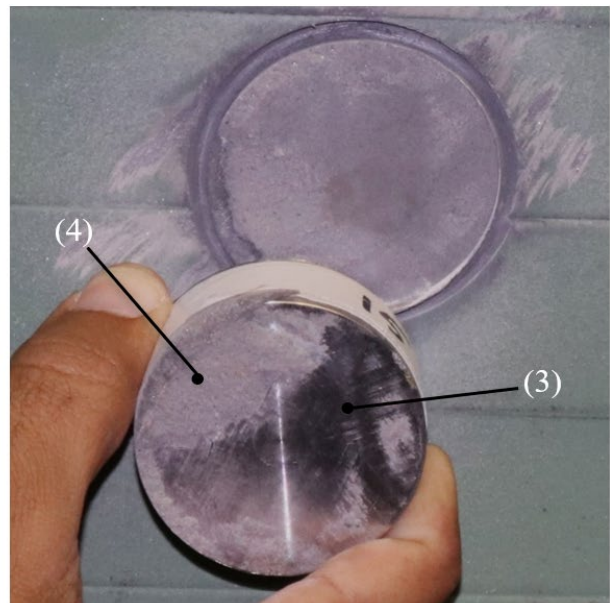
(d)

P15	16 ft. 3 in.		574			
P16	18 ft. 10 in.		>1,145	No failure mode observed, the maximum capacity of the pull-off tester reached	Pull-tests were not successful because of the limited pulling capacity of the pull-off tester.	
P17	19 ft. 7 in.					
P18	20 ft. 3 in.					
P19	20 ft. 11 in.					
P20	21 ft. 8 in.

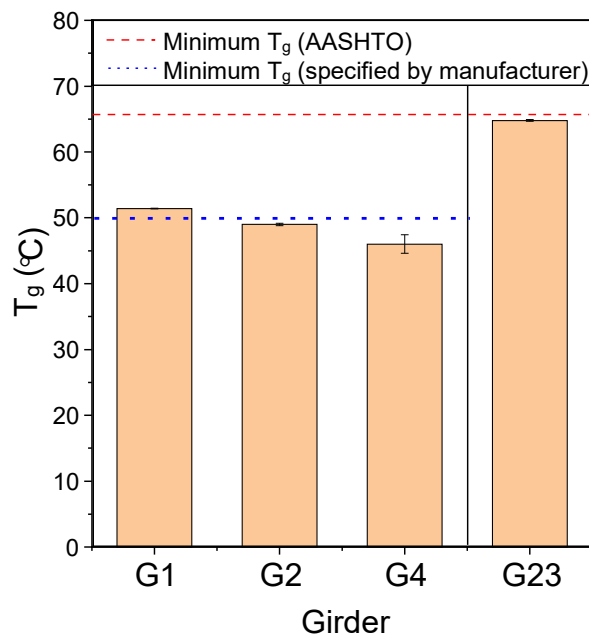
The primary objective of DSC experiments was to determine if environmental exposure during 26-year service life had an effect on the  $T_g$  of the CFRP bridge repairs. Figure 100 shows  $T_g$  of composite samples from girders G1, G2, G4, and G23.  $T_g$  of the CFRP installed in 1994 varied between 46 °C and 51 °C. These values were lower than  $T_g$  of the samples collected from G23 with the  $T_g$  of 65 °C. The lowest  $T_g$  was measured on G4. As shown in Figure 98, CFRP on G1 and G2 seemed more deteriorated compared to other girders. It was expected that the  $T_g$  of composite repairs on G1 and G2 is lower than on G4, since they

seemed more degraded and had more exposure to water, which is related to decreased cross-linking density through polymer chain scission/oxidation/hydrolysis (Lin et al., 2006). Surprisingly, the  $T_g$  values were 10% higher in G1 compared to G4. Lower  $T_g$  observed in G4 could be attributed to different thermal history. It is possible that exterior girders were more exposed to sunlight. Thermal history directly affects the cross-linking density (i.e., exposure to higher temperatures enhances the epoxy-amine reaction and results in stiffer network and higher  $T_g$ ).

Assuming that 50 °C was the initial  $T_g$  value of the FR-E3P resin, it can be concluded that the reduction in  $T_g$  ranged from 0 to 10%. Decrease in  $T_g$  of 10% is lower compared to some results reported on artificially/naturally aged epoxy resin. A decrease in  $T_g$  in the range of 10%–25% was measured during natural exposure in a tropical environment for no longer than 1 year (Lettieri and Frigione, 2011; Belec et al., 2015). Finally, measured  $T_g$  was compared to AASHTO recommendations. Given that maximum design temperature for Delaware is 45 °C, and taking into account AASHTO guidelines (minimum  $T_g$  of 45 °C +21 °C) low values like these are deemed inadequate.

**Figure 100. Glass transition temperature measured on samples from girders G1, G2, G4, and G23.**

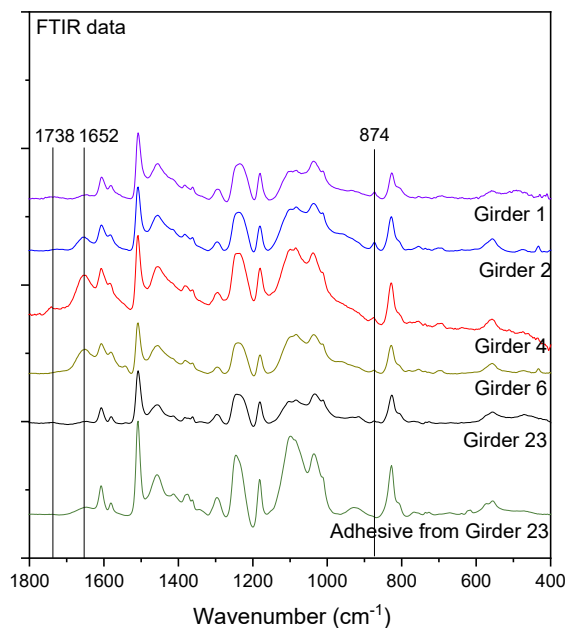
ATR-FTIR spectra are shown in Figure 102. Some differences among the spectra were observed: (1) peak at  $1,658\text{ cm}^{-1}$  is prominent in some samples; (2) peak at  $1,738\text{ cm}^{-1}$  and peak at  $874\text{ cm}^{-1}$  is present in the CFRP samples from G1 and G2, but not in the G6 and G23 samples; and (3) a relatively small peak at  $1,540\text{ cm}^{-1}$  in the spectra of G2 and G6 samples.

Almost all FTIR spectra recorded on G1, G2, G4, and G6 show the presence of the peak at  $1,656\text{ cm}^{-1}$ , which indicates amine cross-linker-related degradation. The appearance of a band around  $1,660\text{ cm}^{-1}$ – $1,670\text{ cm}^{-1}$  is reported in amine-cured epoxies (Delor-Jestin et al., 2006; Meiser and Possart, 2011) after thermal aging, hygrothermal cycling (Lin et al., 2006), and UV exposure and outdoor weathering (Belec et al., 2015; Gu et al., 2005), including thermooxidation under mild conditions ( $70\text{ }^{\circ}\text{C}$ , 80% RH), Morsch et al., 2020). Researchers suggest that the formation of the  $1,657\text{ cm}^{-1}$  band involves a reaction on the phenoxy group and corresponds to quinone methide (Mailhot et al., 2005). According to a different mechanism,  $1,658\text{ cm}^{-1}$  is related to amine cross-linker oxidation. As proposed by Morsch et al., 2020, products of imine hydrolysis contribute to the absorbance at  $1658\text{ cm}^{-1}$  (primary amine N-H bend).

The peak at  $1,738\text{ cm}^{-1}$  was present only in the spectra from G4. This peak was previously reported to correspond to the phenyl formate. The sample from G4 had the lowest  $T_g$ , too (Figure 100). It is difficult to state what would be the underlying mechanism of the observed decrease in  $T_g$ , but the presence of  $1,738\text{ cm}^{-1}$  suggests that the chemical degradation is causing it (possible chain scission reactions in hydroxypropyl ether groups in DGEBA are shown in Figure 101).

**Figure 102. ATR-FTIR spectra of CFRP material samples collected from Foulk Road bridge.**

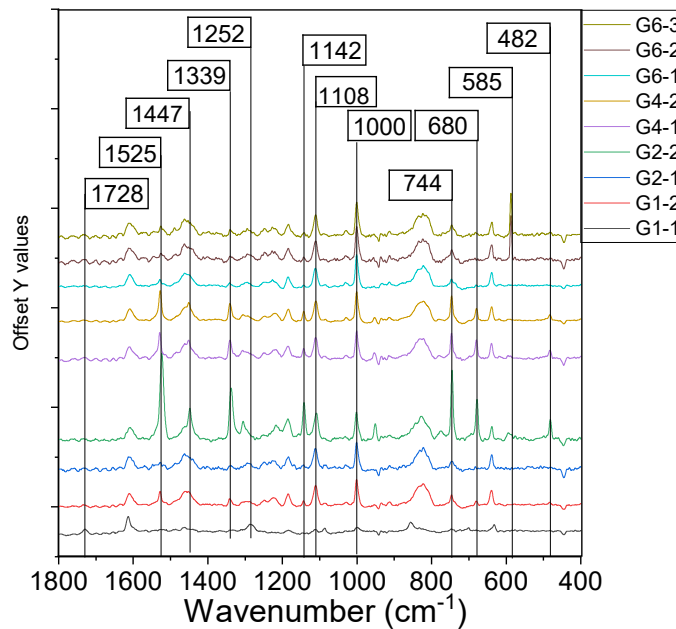
The spectra in the carbonyl range (1,500–1,700) have a poor resolution due to the noise and baseline correction procedures. To provide additional information regarding chemical degradation, Raman spectra were collected. A comparison of Raman spectra recorded on CFRP samples from four different girders are shown in Figure 103. Differences can be noticed at wavenumbers 1,728, 1,525, 1,339, 1,143, 1,000, 744, 680, 585 and 482  $\text{cm}^{-1}$ . Published literature on Raman analysis of epoxy was reviewed to serve as a reference for peak assignment (Daimay, 1991; Fu et al., 2020; Rocks et al., 2004; Vaskova and Kresálek, 2011; Younes et al., 1994; Zapata et al., 2013). Two peaks related to degradation are of particular interest: the peak corresponding to the carbonyl group and the peak corresponding to tertiary amides. Tertiary amides are observed in the Raman spectra in the 700–750  $\text{cm}^{-1}$  range (Daimay, 1991). The issue with using this peak to monitor the degradation of epoxy/amine is that epoxy ring deformation appears in the Raman spectra at 736  $\text{cm}^{-1}$ . Another region of interest is 620–590 related to the skeletal deformation of tertiary amides with R-C(=O)NR<sub>2</sub> type of structure. C=O bands are weak in Raman spectra (Daimay, 1991) and they appear at 1,725  $\text{cm}^{-1}$ . A 1,725  $\text{cm}^{-1}$  peak was observed only in the spectra on G1.

**Figure 103. Raman spectra of CFRP samples - Foulk Road bridge.**

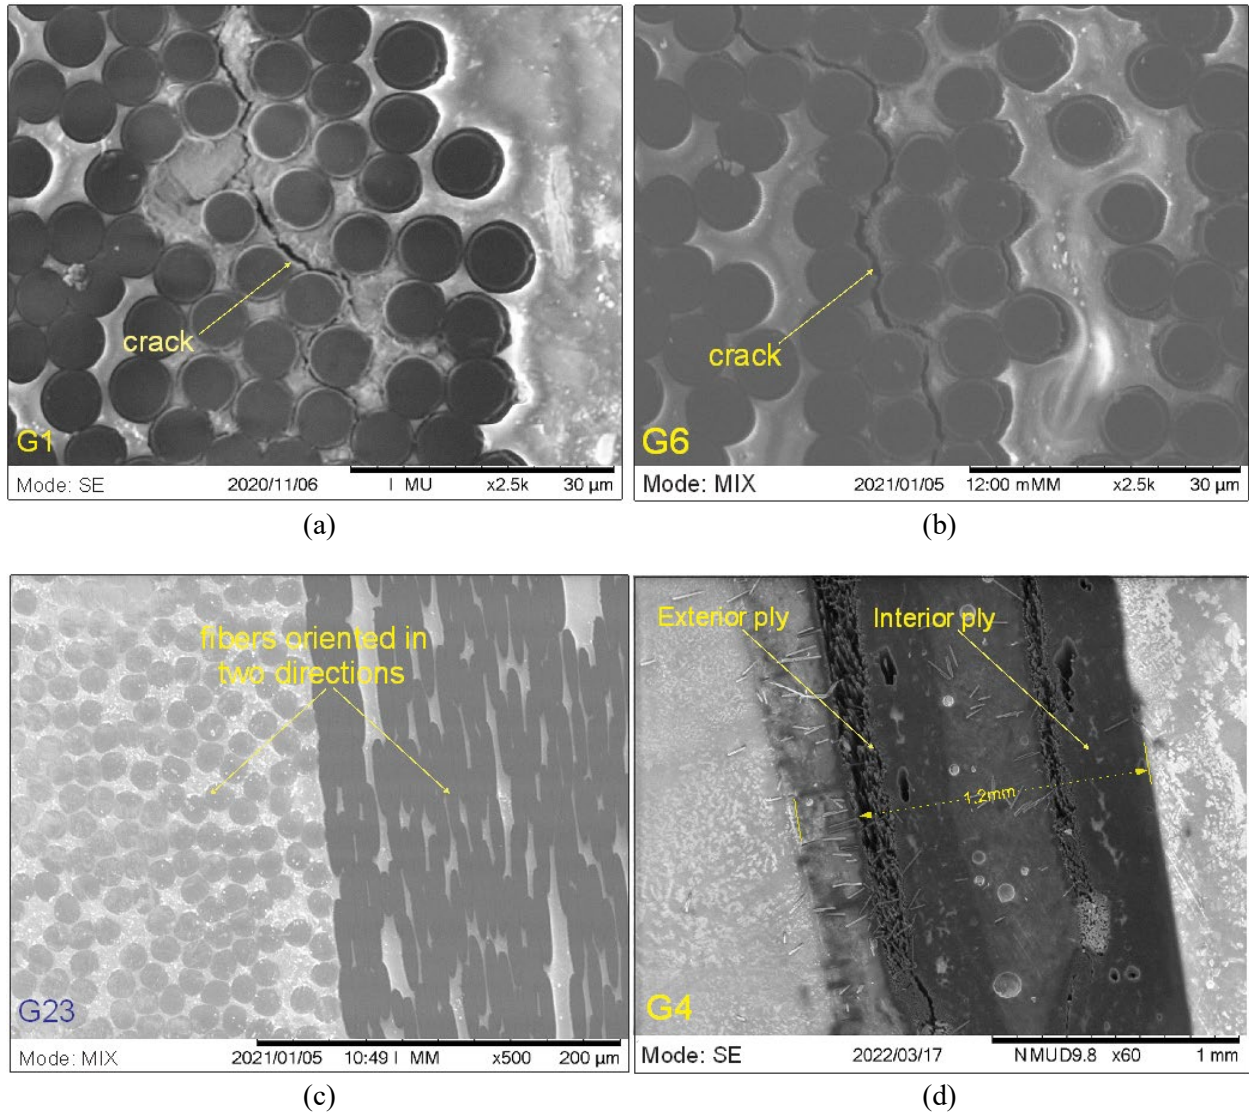
Figure 104 shows typical SEM images of cross-sections of samples collected from G1, G4, and G23. In the CFRP sample from girder G1 (Figure 104a), matrix cracking was noticed at the fiber/matrix interface. Low magnification images in Figure 104 show the non-uniform distribution of fibers that are about 7  $\mu\text{m}$  in diameter. Cracking along the fiber/matrix interface is one of the most common failure scenarios in composite subjected to static loading or fatigue. This damage mechanism is initiated by the formation of local fiber/matrix debonding, which proceeds until cracks coalesce into one large crack (Pupurs, 2012). This leads to stiffness reduction and eventually results in composite failure (Pupurs, 2012). No evidence of damage was observed in the sample from girder G23 (Figure 104b).

Figure 104c presents a typical SEM image of the sample from girder G4. The image shows two plies of CFRP (~0.5 mm) with a layer of epoxy in between. SEM images show damage in both plies of CFRP but not in the epoxy layer between them. The surface of the exterior ply is the most deteriorated part. Composite damage includes loss of matrix and completely exposed fibers. Synergistic actions of mechanical stress, water diffusion, and temperature are the most likely causes of the composite degradation. The breakdown of resin molecular chains and leaching of broken chains likely increased sensitivity to water uptake, which accelerated resin degradation and fiber-matrix interface.

**Figure 104. SEM images of CFRP: (a) cracking at the fiber/matrix interface in G1, (b) cracking in the region of closely spaced fibers in G6, (c) bidirectional CFRP, (d,e) cracking and loss of matrix two-ply CFRP on G4, and (f) high magnification image showing exposed fibers in G4.**

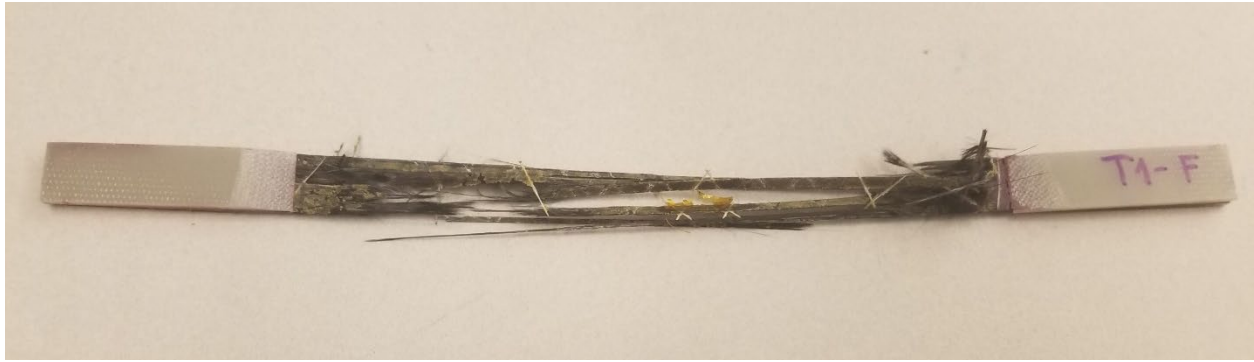
The average tensile strength was 318 ksi, which is 37% less than the value specified in the materials data sheet—483 ksi. Failure mode can be best described as a staggered failure, with fiber pullout and debonding along the fibers (Figure 105). The load vs. time curve in Figure 106 shows the propagation of the failure where bundles of fiber progressively fail at different locations along the coupon length. As shown in the SEM images, there were many defects in the matrix – cracking and matrix erosion. These defects probably decreased composite strength, since there was not enough resin to ensure uniform distribution of stress between the fibers. According to ACI 440.2R, the environmental reduction factors are applied to CFRP properties and vary between 0.85 and 0.95 depending on the environmental exposure. For CFRP installed on bridges, ACI 440.2R recommends an environmental reduction factor of 0.85. The calculated value of  $C_E$  based on strength data in Table 11 was 0.66, which is significantly lower than the value recommended in ACI 440.2R.

Figure 105. Typical failure mode of tensile test coupons.

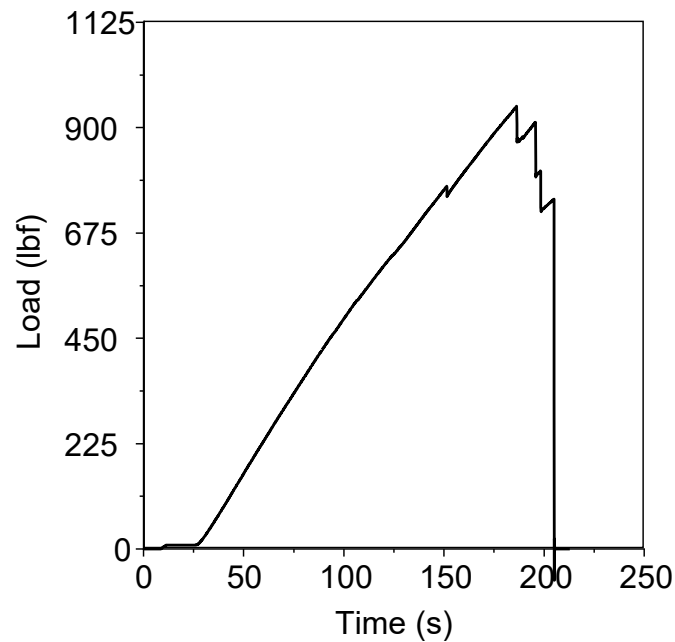
Figure 106. Load vs. time curve (strain gage failed before the coupon failure, so part of the strain data is missing).

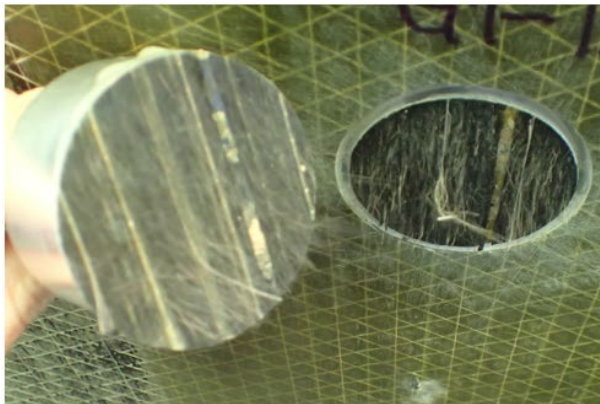
Label	Bond Strength (psi)	Failure Mode	Failure Mode	Interpretation of Failure Mode
G1-U1	354	B	Cohesive failure in CFRP laminate	Indicates that the perpendicular (tension) force that the CFRP composite can withstand is lower than the tensile strength of concrete and epoxy adhesives, and the bond strength at all interfaces. Such failures are likely due to incomplete wet-out of the fibers or plies comprising the laminate or environmental degradation of the CFRP.
G1-U2	409	B	Cohesive failure in CFRP laminate	
G1-U3	312	B	Cohesive failure in CFRP laminate	
G4-UD1	25	B	Cohesive failure in CFRP laminate	
G4-UD2	0	B	Cohesive failure in CFRP laminate	
G23-B1	138	E	Adhesive failure at CFRP/concrete substrate interface	Indicates poor adhesion properties, likely resulting from improper selection of adhesive for concrete substrate, contamination of adhesive, incomplete or improper cure of adhesive, environmental degradation, or improper installation.

**Figure 107. Two failure modes observed: (a) mode B on G1-U1, (b) mode E on G23-B1, (c) mode B on G4-UD1, and (d) mode B on G4-UD2.**

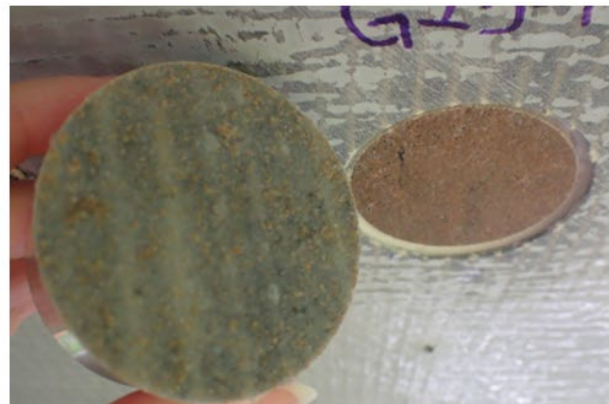
(b)

G23-B2	194	E	Adhesive failure at CFRP/concrete substrate interface	
G23-B3	637	E	Adhesive failure at CFRP/concrete substrate interface
